# Failure of an Embankment on Soft Clay

M. K. Yegian

**SYNOPSIS** The failure of an embankment during its construction on soft clay foundation is investigated. Field and laboratory data are used in conventional slope stability analyses to explain the cause of the failure and to evaluate the in-situ undrained shear strength of the clay which was later used in the design of the replacement dike. The results indicate that whereas the stiff embankment having a well compacted core was initially stable on the soft clay, subsequent cracking of the core due to undrained deformations reduced the shearing resistance of the dike thus, initiating the failure. The dike was eventually reconstructed in stages allowing enough time between stages for the foundation clay to consolidate and increase its shear strength. In the new dike a granular material was used in order to provide flexibility and to prevent cracking of the dike. In addition, long berms were placed on both sides of the dike to increase its stability. Field instruments including piezometers and inclinometers were used to monitor the rate of the stage construction of the new dike.

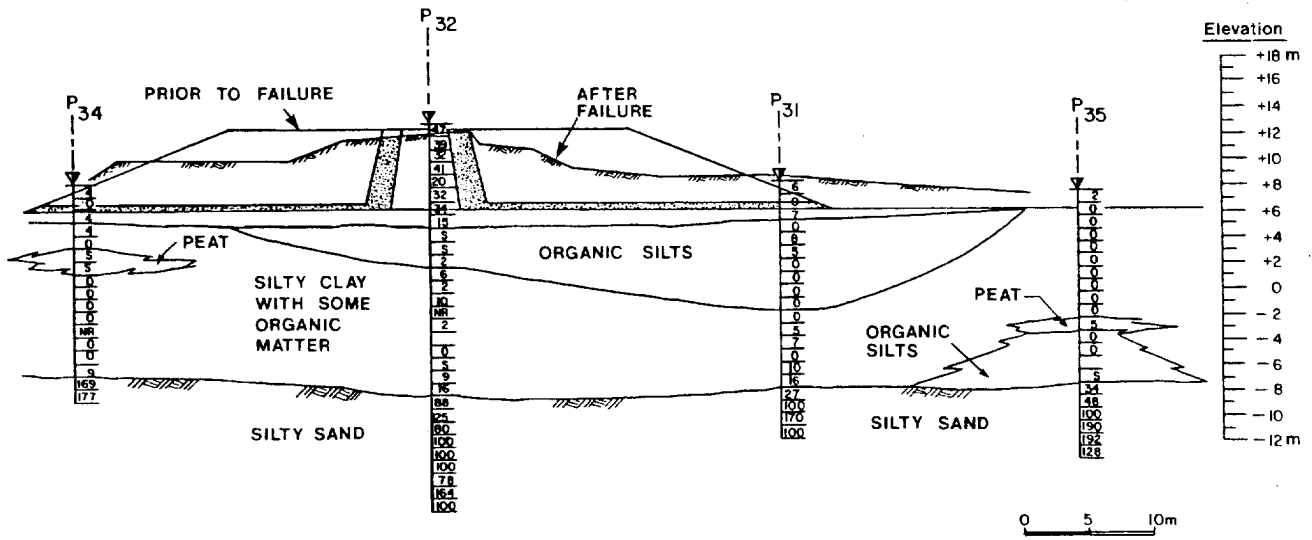
Figure 1 Cross-section of Dike Prior to and After Failure

Two and a half months after construction had started, a large section of one of the dikes, failed by sliding into the lagoon. The height of the 400 meter long dike at the time of failure was about 7 meters, (4 meters below the final design crest elevation). The dike consisted of a well compacted clay core and shell of sand, gravel and rocks. Immediate attempts made by the contractor to reshape the dike and to continue its construction resulted in similar failures in the same zone as that of the initial failure. Following these failures, extensive field and laboratory investigations were made, including; soil boring, sampling, testing and installation and monitoring of field instruments. The information obtained from this subsurface exploration program was then utilized in geotechnical engineering analysis and the causes of the failure of the dike were identified and an alternate design and construction procedure was adopted and the

Immediately after the failure of the dike, topographical data was acquired and the extent of the failure of the dike and its shape after failure were established as shown in Figures 1 and 2. Following this, standard penetration tests were made using a sampling spoon of 2-in OD with a 140 lb. weight hammer falling 30 inches. Figures 1 and 2 show the locations of a few of the bore holes and their corresponding logs. In addition to the Standard Penetration Tests, geophysical investigations were conducted along a number of traverses and the thicknesses of different soil layers were estimated as shown in Figures 1 and 2.

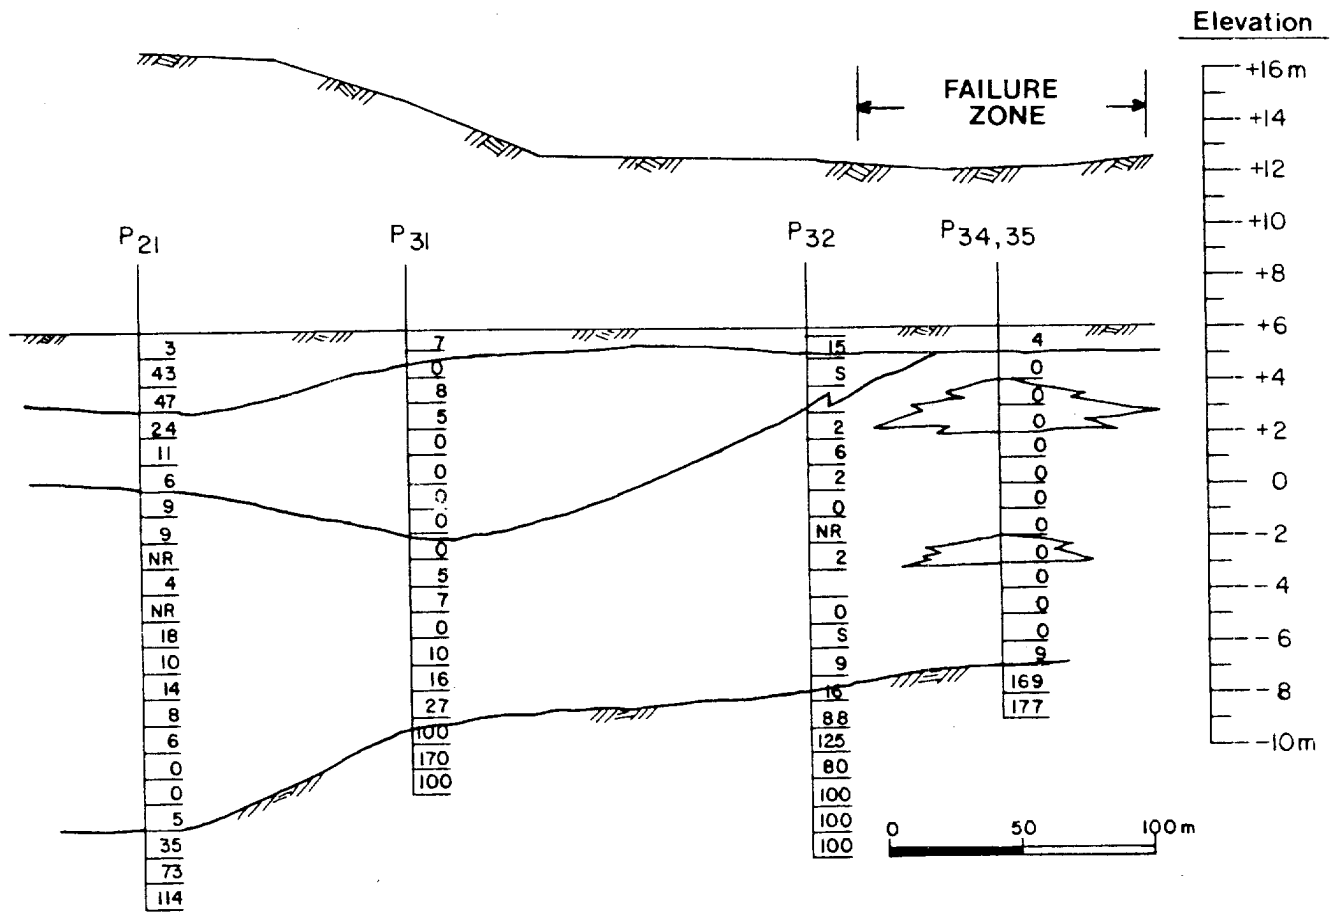
Figure 2 Subsurface Profile Along the Longitudinal Axis of Dike

Based on these field investigations and visual inspections of samples of soil retrieved from the field tests soil profiles were prepared as shown in Figures 1 and 2. In summary, the site consists of flood-plain deposit of low-to-medium plasticity silts and silty clays containing some organic matter and interrupted by layers and

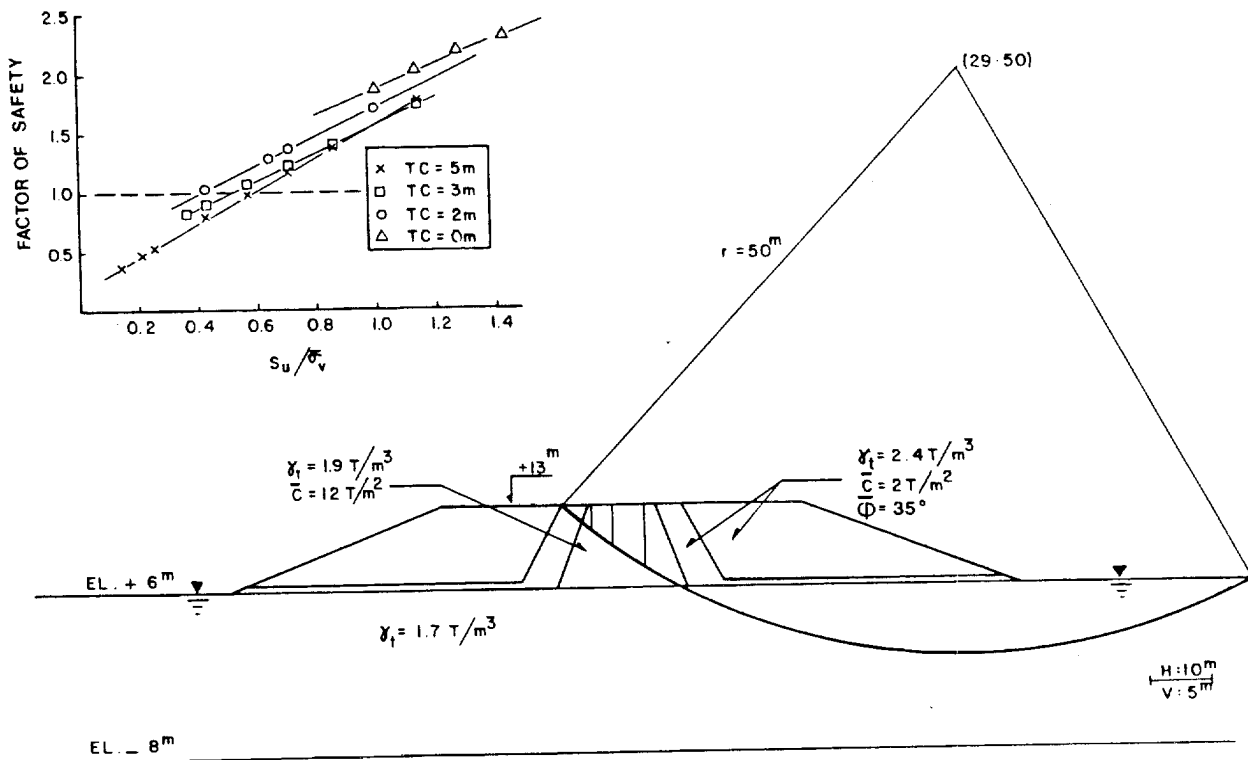
Figure 4 Total Stress Stability Analyses of the Dike, Prior to Failure

dike was stable and in a way floating on its large base over the saturated clay. But, as the construction of the dike proceeded, the resulting large undrained deformations initiated the cracking of the core, thus, reducing the shearing resistance of the core and ultimately causing failure. Also, since the dike did fail (F.S. < 1.0), from the results of the stability analyses it is concluded that the undrained shear strength ratio  $S_u/\bar{\sigma}_{vo}$  for the clay should be less than 0.5.

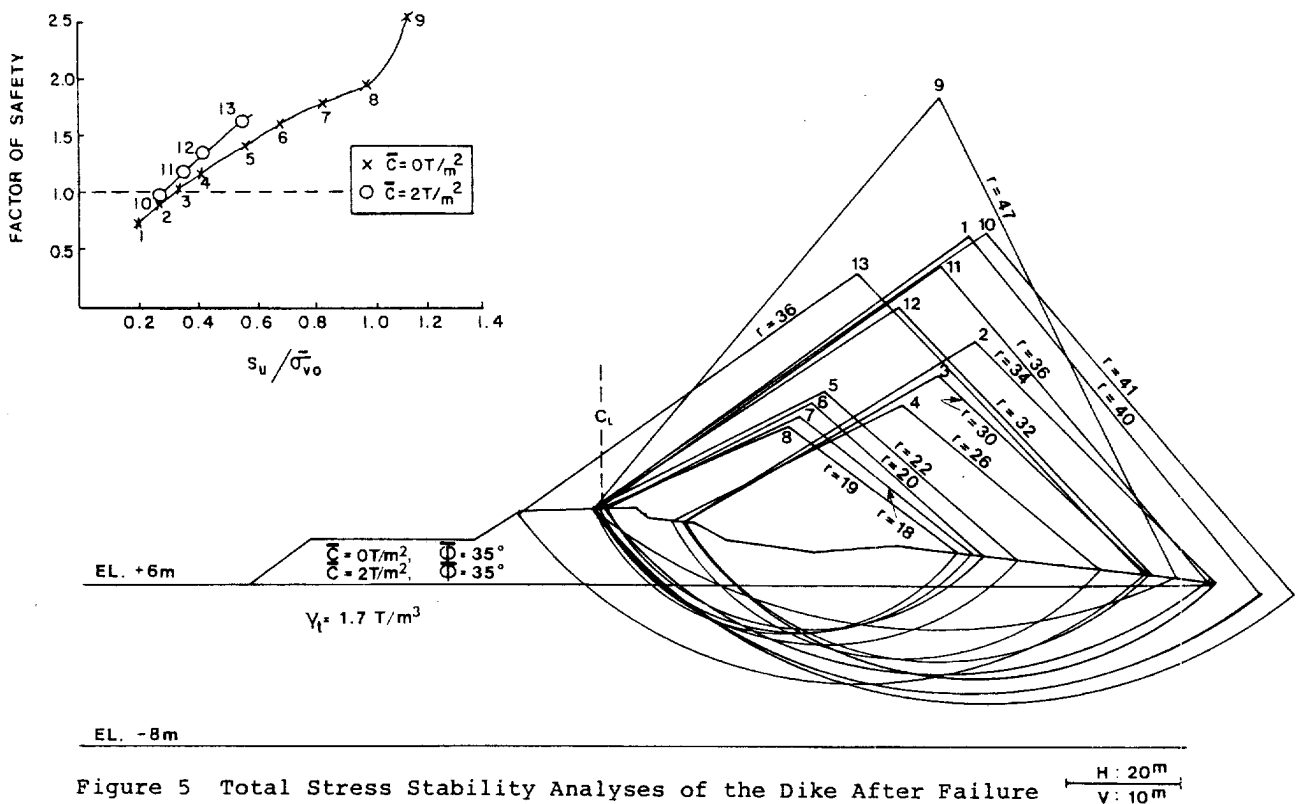
Figure 5 Total Stress Stability Analyses of the Dike After Failure

The total stress stability analyses were repeated using the cross section of the dike after failure determined from topographical surveys. Figure 5 shows a cross section of the dike observed after failure. The stability analyses of the dike were made searching for the critical failure circle and considering a tension crack of 5 meters extending through the core. Since, after the failure, the factor of safety was greater than or equal to 1.0, from these analyses, it is concluded that the undrained shear strength ratio  $S_u/\bar{\sigma}_{vo}$  should be greater than 0.3.

In summary, the results of the stability analyses of the failed dike for conditions immediately before and after the failure indicate that the embankment material was well compacted and thus, the shear strength of the fill provided enough resistance against immediate major stability failure during the early period of its construction. However, as the dike underwent deformations due to continued undrained loading, it started to crack, thus losing shearing resistance and initiating failure. The undrained

shear strength ratio  $S_u/\bar{\sigma}_{vo}$  of the foundation clay as determined from laboratory tests was 0.25. Based on the results of these stability analyses it was concluded that this ratio determined from laboratory tests is small because of sample disturbance and is more likely to be 0.3, which agrees better with published values for similar soils. This value of  $S_u/\bar{\sigma}_{vo} = 0.3$  was later used in the analyses made for the reconstruction of the failed dike.

For the reconstruction of the dike, alternate methods were investigated considering various constraints including: Construction timing and scheduling, required materials, cost of construction and reconstruction technique. In view of the fact that there was a delay in the completion of the alumina plant and therefore the dike would not be needed for another two years, and also the permeability of the foundation soils as indicated by the piezometers was larger than estimated in the laboratory, it was decided to adopt a stage construction procedure. By this method, the construction of the dike proceeded in stages allowing enough time between stages for the clay to consolidate and gain the required strength to achieve safety against stability failure. In addition, in order to permit construction to proceed during the "high water" seasons and to provide a flexible embankment, a granular material was used in the dike and the compacted core was eliminated. Furthermore, 13m berms were placed on both sides of the new embankment in order to provide additional stabilizing forces.

In order to predict the safe height of the dike for each stage of construction and to make estimates of the required duration in time of the different stages of loading, total stress stability analyses were made. Based on these results it was concluded that the dike could be raised to a minimum required height of +14m in time for the operation of the plant. In addition, effective stress stability analyses were made to determine the limiting pore water pressures in the foundation clay below which the dike would be safe at each stage of construction.
