The Manjil, Iran Earthquake of June 21, 1990

Contribution by Abolhassan Astaneh, EERI Reconnaissance Team Leader, USA, and M. Ghafory Ashtiani, Head, IIEES, Iran.

Contribution by M. K. Yegian, Professor and Chairman, C.E. Dept., Northeastern University, and V. G. Ghahraman, PhD Student, C. E. Dept., Northeastern University.

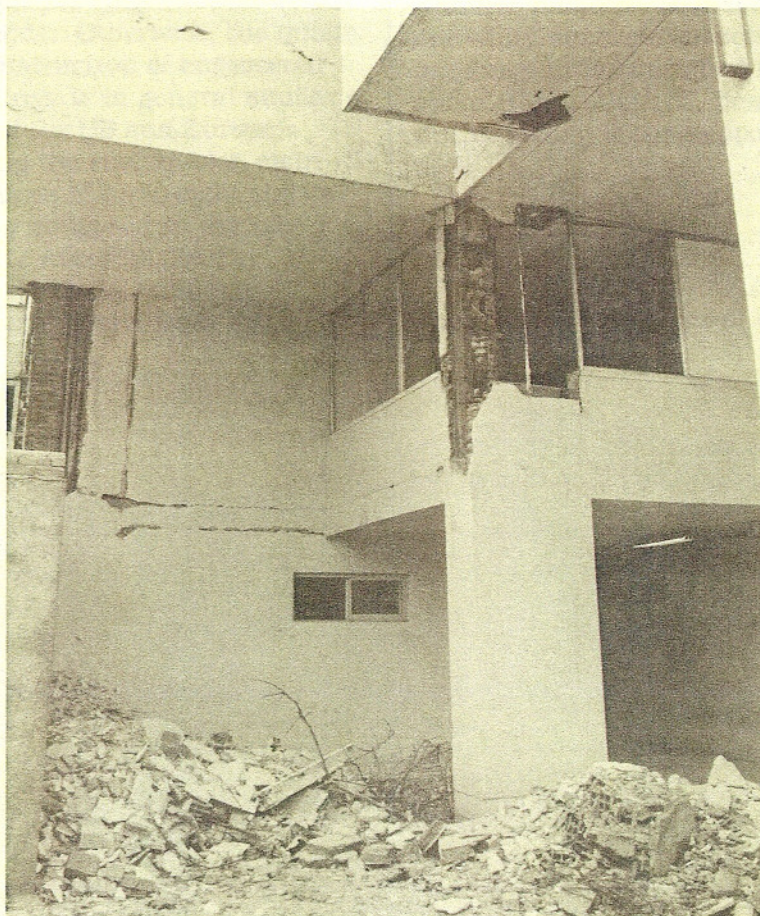
Damage to exterior of the hotel Bozorge Guilan

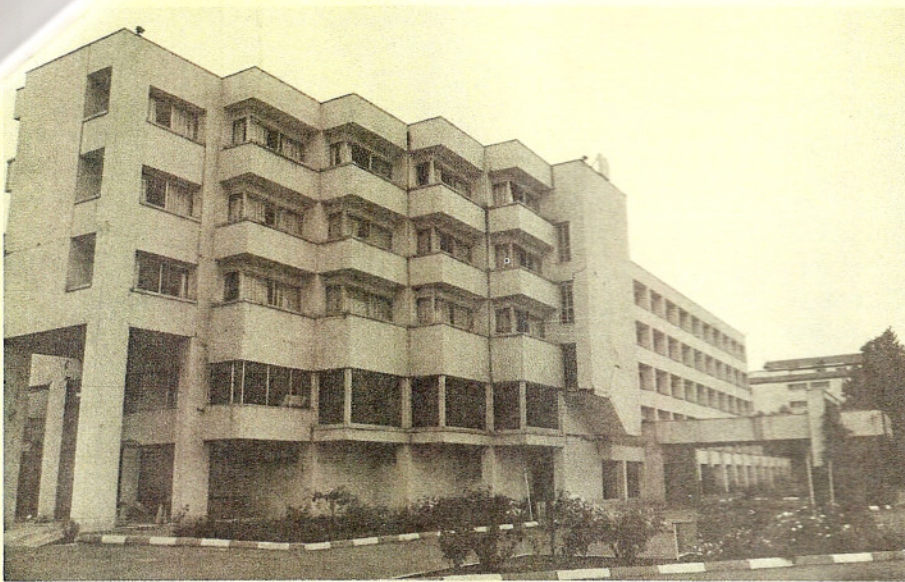
Damage to exterior of the hotel Bozorge-Gullan.

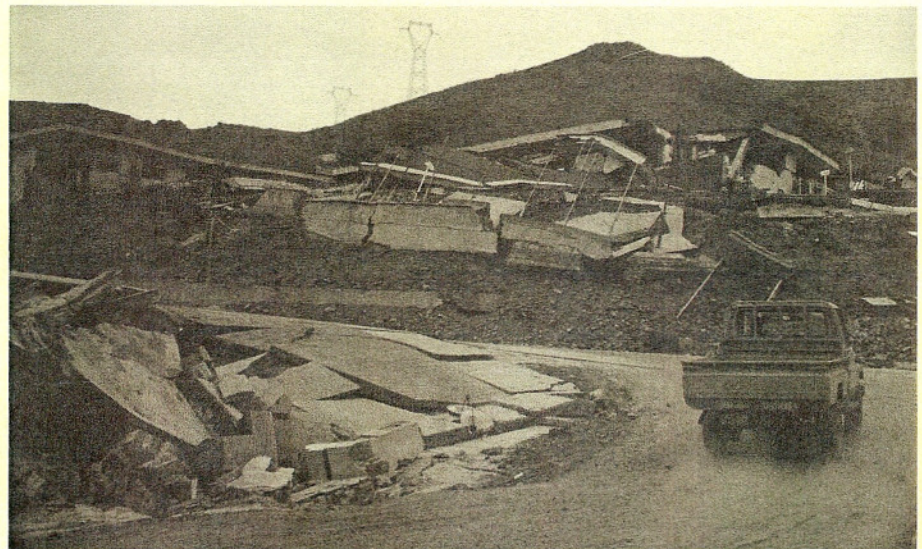
A major hospital with several one-story concrete masonry buildings in Rostamabad had completely collapsed, possibly due to sliding of the supporting soil.

Collapse of Rostamabad Hospital, (about 15 miles from the epicenter).

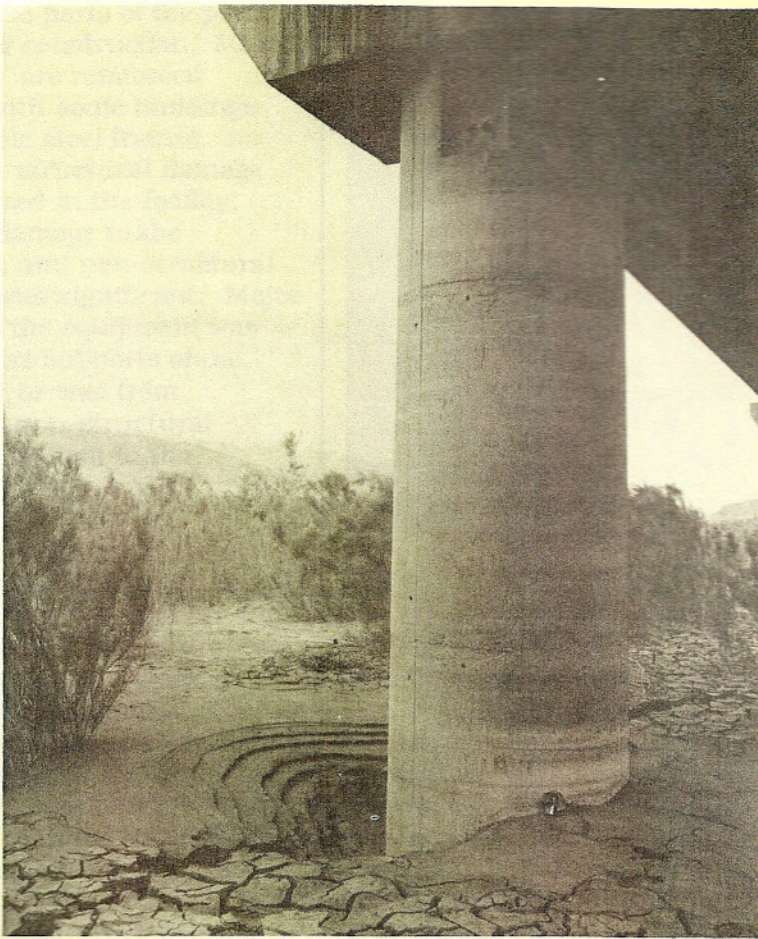
Some evidence of liquefaction was observed in the town of Astaneh-Ashrafieh where sand boils had completely filled up 8-10 meter deep water wells. Also, due to liquefaction, several houses were unevenly uplifted, or sunken resulting in severe damage. Further evidence of liquefaction and sand boils was observed under the Bala-Bala bridge.

Soil liquefaction and sand boils under Bala-Bala bridge.

in the affected area: steel truss bridges, concrete bridges and old brick masonry arch bridges. Steel bridges had no damage. Two of the old arch bridges located within 15 miles of the epicenter had severe damage, resulting in closing one of two lanes. Damage to three major concrete bridges in the area within 20 miles of the epicenter was limited to pounding of longitudinal stringers against each other or against abutments, causing minor concrete spalling in structural members and major damage to non-structural sidewalks. At least one of the piers of the Bala-Bala bridge had a horizontal crack about 5 feet from the top of pier. The drybed of the river underneath the bridge showed numerous sand boils and a major subsidence of about 6 feet.

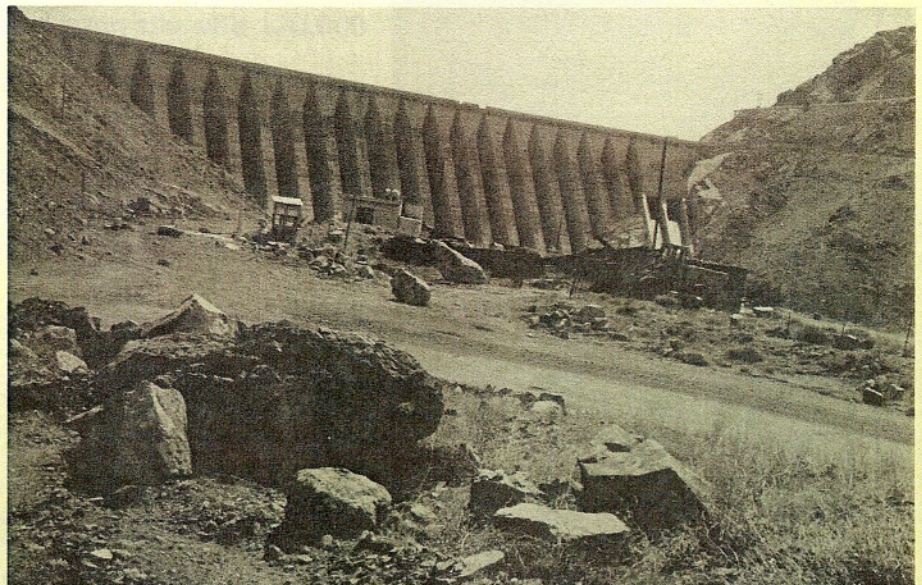
Sefidrud Dam which sustained minor damage.

meters from the causative fault. The construction of the dam was completed in 1967 and was designed for 0.25g horizontal equivalent static force. The dam is 106 meters high and at the base has a width of about 100 meters. The length of the dam at the top is 425 meters. The dam sustained minor damage in the form of horizontal cracks developing at the highest construction joint. Apparently this joint was about 9 meters below the water level at the time of the earthquake. After the quake, the water was drained, and the water level was below the crack line 4 days after the quake, when the EERI team visited the dam.

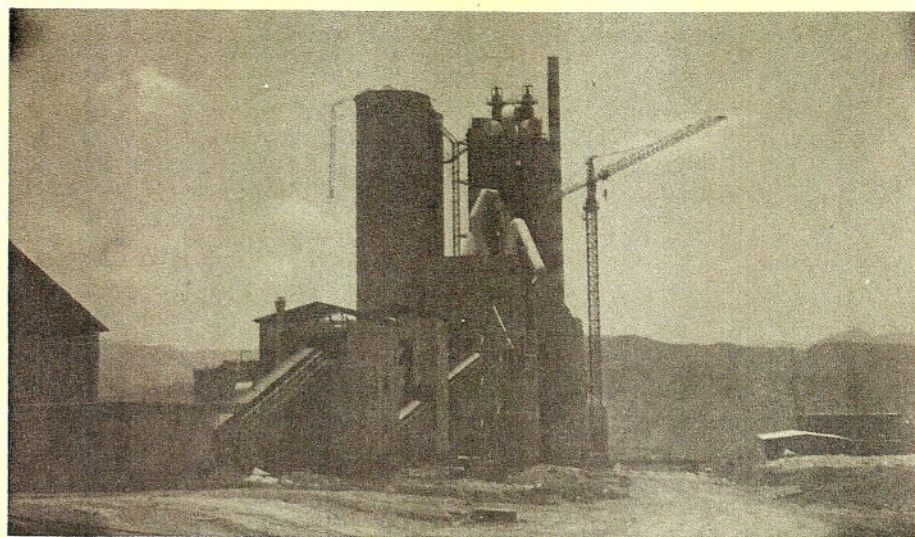
years. Some parts of the plant were under construction. Most structures are reinforced concrete with some buildings having gable steel frames. No significant structural damage was observed in the facility. However, damage to the equipment and non-structural elements was significant. Major damage to the equipment was failure of the supports of the equipment or was from collapsing non-structural elements adjacent to the equipment.

Part of the Lushan cement factory.

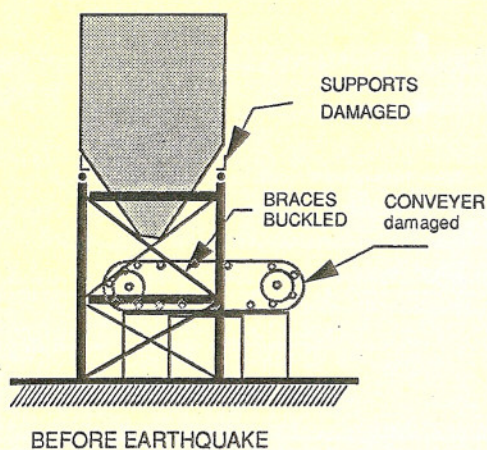
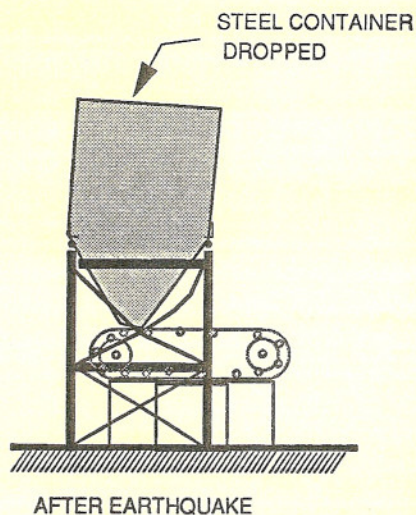
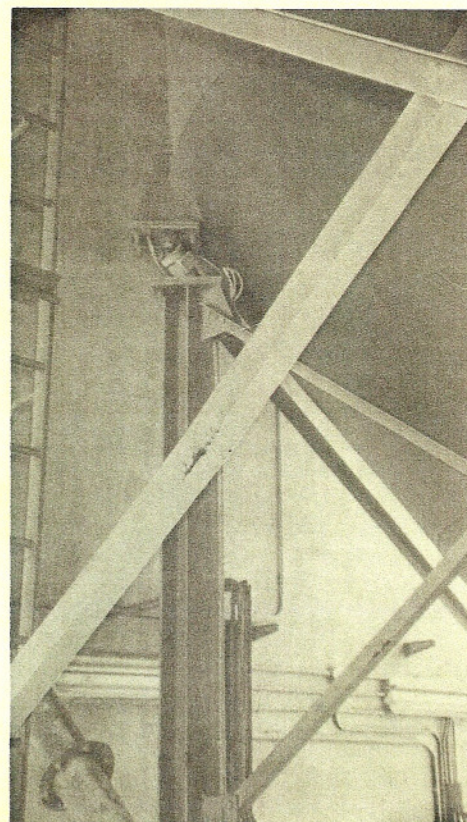
Three of the four main steel containers that were used to store and feed raw material for cement production had dropped down about 10 inches due to failure of their supports. The supports in some cases had instrumentation, and acted as load cells to measure the weight of the raw material to be fed to the production line. The load cell supports did not appear to have sufficient provisions to prevent horizontal movement of the container. As a result, the supports had collapsed in an overturning manner causing these large and heavy containers to drop. Even though the containers did not seem to have been damaged, the impact had buckled diagonal bracing of the supporting structure and had

damaged the equipment below and the conveyer belt system.

Collapse of support of main containers at Lushan cement factory.

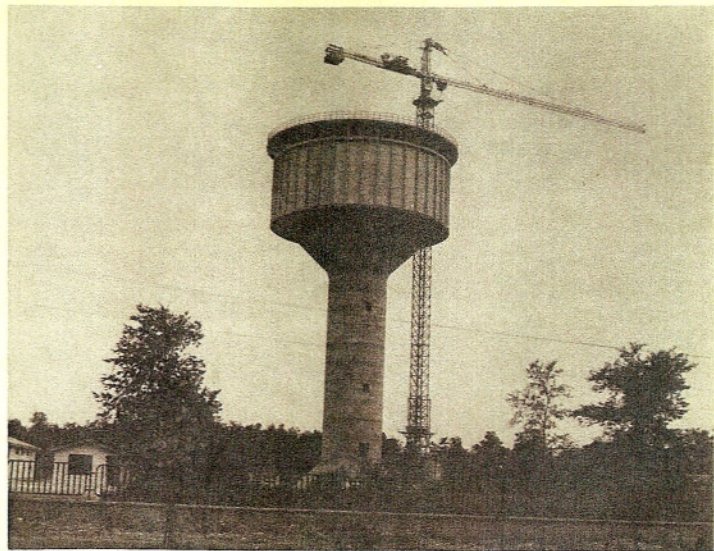
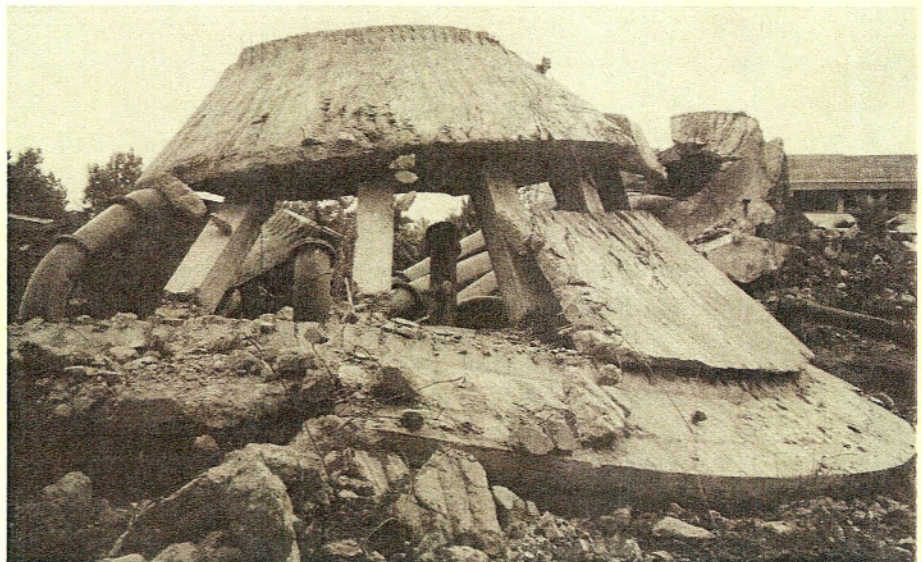
There were three almost similar elevated reinforced concrete water tanks in Rasht. One tank was operational but totally collapsed during the earthquake. The two other tanks were under construction and horizontal cracks developed near the base of the main supporting pipe along the top of the opening.

Empty R/C elevated tanks developed cracks, while full tank collapsed.

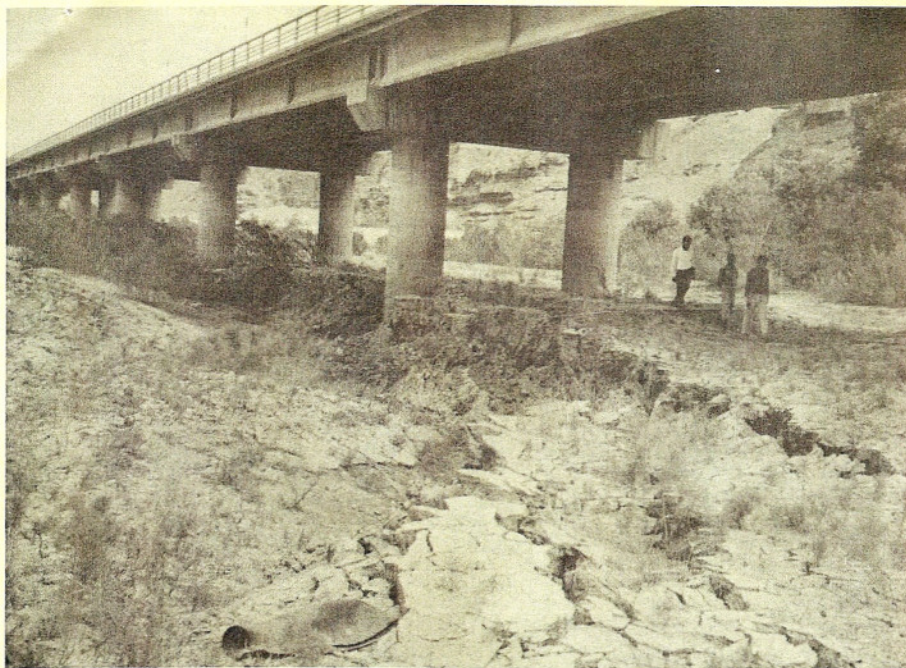
Soil liquefaction and sand boils under Bala-Bala bridge.
