The Northridge Earthquake of 1994: Ground Motions and Geotechnical Aspects

Paper No. 14.01

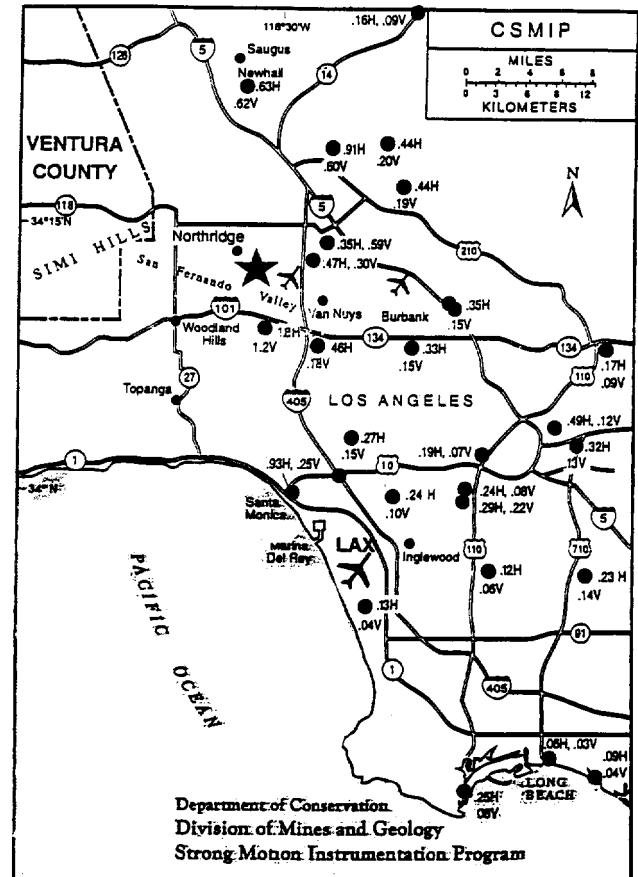
Fig. 1 Map of peak accelerations from CSMIP.

- Along and near Highway I-10, the peak ground accelerations (PGA's) vary from 0.93g at the City Hall near the Santa Monica Beach (24 km from the

epicenter) to 0.27g at the Century City-LACC site (20 km from the epicenter), with the Hollywood Storage building site reaching an intermediate 0.41g value (23 km from the epicenter). Since these sites are at similar distances, and in the same general direction from the fault, soil "amplification" effects appear to be the most likely reason for the large differences in the recorded accelerations.

- In the Long Beach area, nearly 60 km from the epicenter, several records exhibit PGA's in the range of 0.06g to 0.09g. Yet, nearby, at the base of Vincent Thomas Bridge, the recorded peak acceleration was 0.25g. For the reasons stated above, soil "amplification" is again a very likely culprit.
- In the San Fernando Valley, and in its northern extension, peak accelerations vary widely, almost regardless of epicentral distance. Examples: Olive View Hospital 0.91g (distance = 15 km), Arleta Nordhoff Ave. Fire Station 0.39g (distance = 9 km), Newhall 0.63g (distance = 19 km), Sepulveda VA Hospital 0.94g (distance = 8 km). Soil amplification effects may have played a role in such differences, although, so close to the source other seismological factors, including azimuthal orientation and "directivity" effects, may have contributed as well.

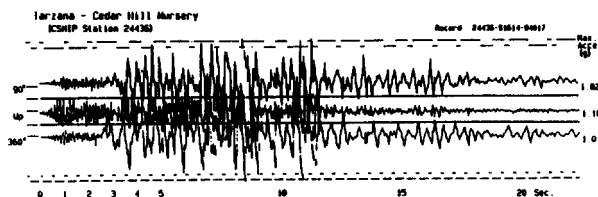
The second is at the Tarzana Cedar Hill Nursery located about 7 km from the epicenter. The ground motion record at this site displays an unusually large number of pulses with peak acceleration values of 1.82g and 1.01g in the two horizontal directions, and 1.18g in the vertical direction. Fig. 2 shows the traces of the ground motions recorded in Tarzana. Similar "anomalously" high ground motions (PGA \approx 0.60g) were also recorded in Tarzana during the 1987 Whittier earthquake (epicentral distance \approx 40 km). Tarzana is located at the northern foothills of the Santa Monica mountains. Very localized soil and, especially, topographic effects may have contributed to these high motions.

Fig. 2 Ground motion record from the recording station in Tarzana (3 components).

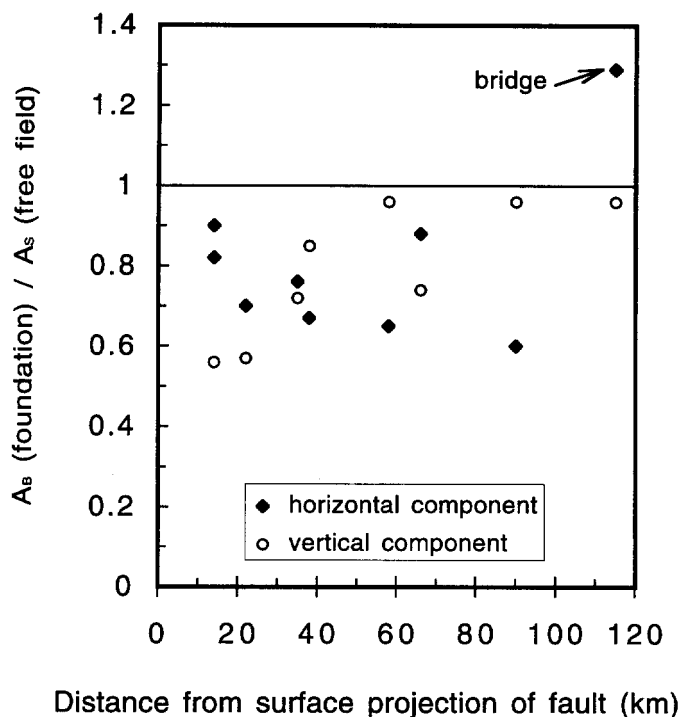
Another phenomenon of geotechnical interest that appears to have played a role in the seismic performance of bridges and buildings is called *soil-structure interaction*. In simple words, the term describes the unavoidable interplay between a structure (building, bridge pier, bridge abutment) and its supporting soil. One is transmitting forces to the other, while their motions must be compatible. Unfortunately, it is very difficult to actually "observe" this interplay in the field after an earthquake. There have, however, been several instrumental manifestations of the phenomenon. For instance, in nearly all cases where accelerations were recorded in both the parking lot ("free field") and the base of a structure, the measured peak accelerations were different. In buildings, the peak base motion was usually only about 80% of the "free-field" peak. Examples: Hollywood Storage building: 0.29g at the base versus 0.41g at the free field; Los Angeles University Hospital: 0.37g at the base versus 0.49g at the free field; and so on. Fig. 3 summarizes a compilation of all such data, in the form of the ratio of peak accelerations recorded at the foundation and the free field, A_B/A_S . Notice that for all buildings this ratio was less than 1.

Fig. 3 An indication of the effect of soil-structure interaction is that the ratio of peak acceleration, A_B , recorded on the base of buildings (foundation) was almost always smaller than the peak ground acceleration, A_S , at the nearby parking lot (free field).

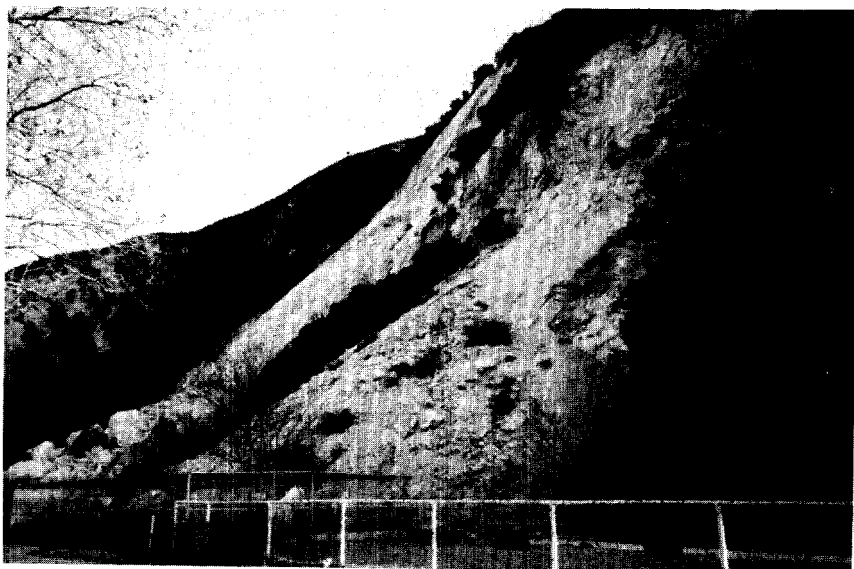
There were a number of rock slides that were observed mostly in the region north of the epicenter. Fig. 9 shows photographs of typical rock slides. In Santa Monica, along the Pacific Coast Highway, spectacular landslides occurred damaging many of the homes built on the cliffs overlooking the Ocean. Fig. 10 shows a section of this landslide. Also, in Simi Valley, a major slide occurred in a slope built with the tailings from a mining operation. Fig. 11 shows the failed slope where lateral and vertical permanent deformations were as large as 1 m and 2 m, respectively. A survey of the slope region revealed that water used in the mining operations is directed through trenches away from the top of the slope towards its toe. The failed slope was observed to be free of ground water. Geotechnical investigations including analysis of the strength properties of the tailing may lead to definitive reasons for this failure.

Fig. 9 Rock slides in the region north of the epicenter.

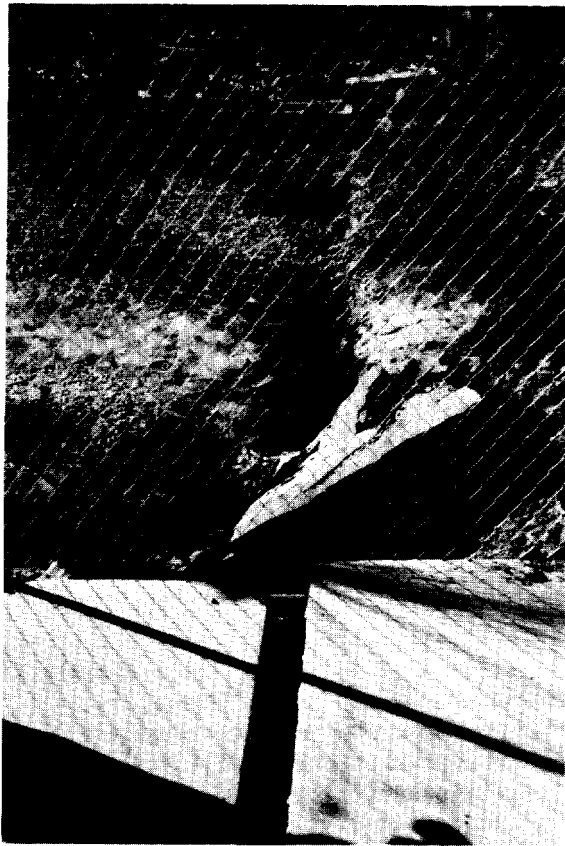
In Granada Hills, on Balboa Street, immediately north of Highway 118, there was evidence of significant permanent ground deformations. About three blocks along this street, and one block on each side of the street, there were many cracks in the ground running perpendicular to Balboa Street. Some of these were tensile cracks with widths as large as 6 to 10 inches, as shown in Fig. 12. Other cracks were of compressive type resulting in ridges in the sidewalks, as shown in Fig. 13. In this section of Balboa Street, there were many ruptures of gas lines leading to fires that destroyed many residential houses. Also, the water main in this section of Balboa Street ruptured causing major floods. The cause of these ground fissures is not well understood yet. Since the fault in this region is closer to the ground surface than anywhere else in the Valley, it is possible that the ground deformations in this region within the San Fernando Valley,

have a more direct connection with the fault rupture. Alternatively, since the cracks in the ground are limited to the section of Balboa Street that is on a hill, shallow slope failures (where blocks of soil moved downhill and relative to one another) can not be precluded as a reason for these cracks.

Fig. 12 Ground fissures along Balboa Street in Granada Hills.

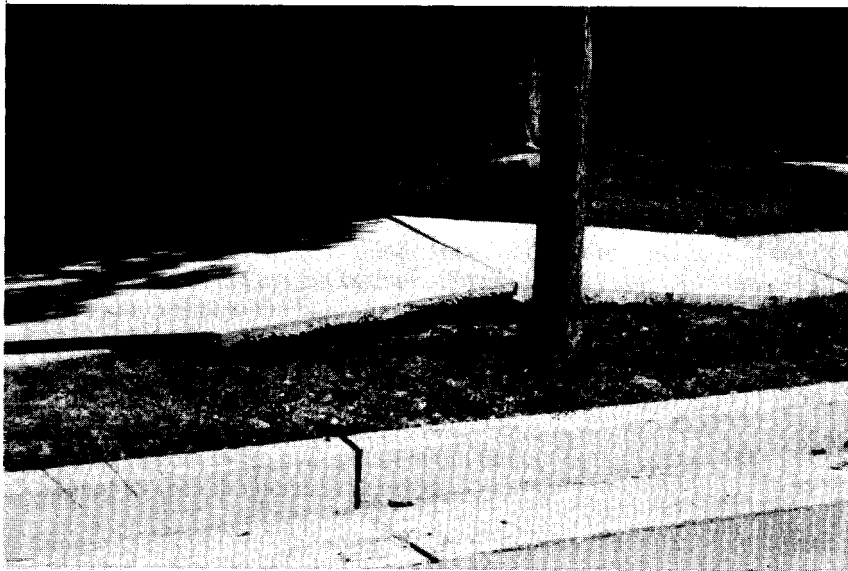
Fig. 13 Compressive ground deformation along Balboa Street in Granada Hills.
