## 1988 ARMENIA EARTHQUAKE. II: DAMAGE STATISTICS VERSUS GEOLOGIC AND SOIL PROFILES

By M. K. Yegian,<sup>1</sup> V. G. Ghahraman,<sup>2</sup> and G. Gazetas,<sup>3</sup> Members, ASCE

**ABSTRACT:** This is a companion paper dealing with engineering aspects of the surface-wave magnitude  $M_s$  6.8 1988 Armenia earthquake. The first paper, by the same writers and in the same journal issue, provides an overview of the seismological, geological, geotechnical, and structural aspects of the earthquake. The present paper offers building-damage statistics in the cities of Leninakan and Kirovakan, Armenia. These statistics are qualitatively correlated to the soil profiles to assess the potential importance of any soil amplification effects. The results indicate that in Leninakan, located in a very wide valley, the soil had some effect but could not have been solely responsible for the tremendous damage in the city. In Kirovakan, the soil profiles vary significantly within the city. Damage was primarily within a limited region where there is a valley filled with stiff clays and having width-to-maximum-depth ratio of approximately 5:1. In this region, 74% of the buildings collapsed or were

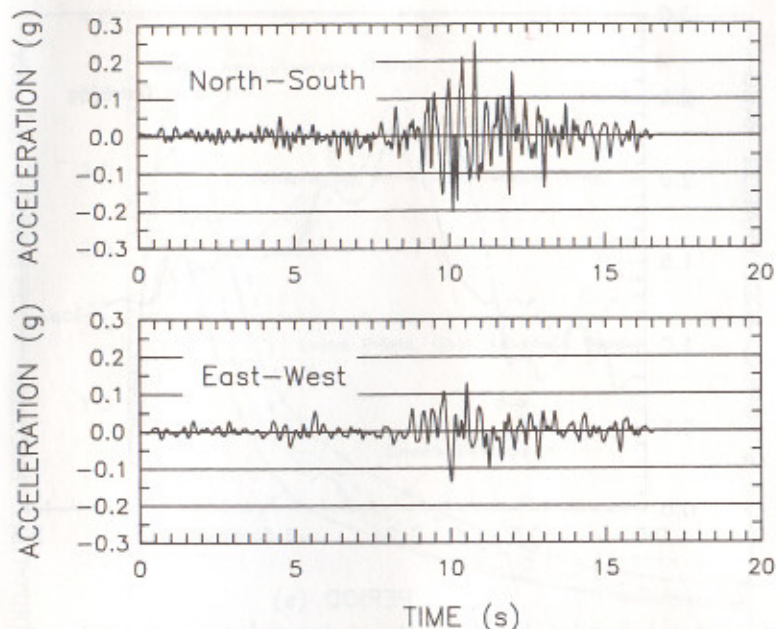
FIG. 5. Time Histories and Response Spectra of Back-Calculated Rock Outcrop Motion in Ghoukasian

Fig. 5 shows the computed outcrop rock time histories and their respective response spectra for the N-S and the E-W components. Fig. 6 plots the ratios of each response spectrum at the ground surface divided by the corresponding calculated response spectrum at the rock outcrop. Note in this figure that the Ghoukasian site has a relatively long calculated fundamental period, ranging between 0.8 s and 1.2 s, which is arguably responsible for the presence of high-period pulses in the surface recordings of Fig. 2.

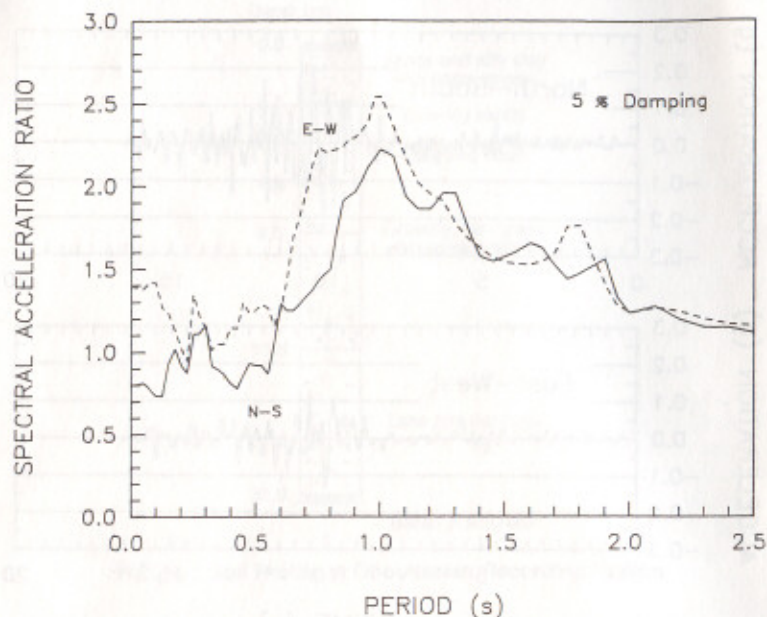
FIG. 6. Computed Ratios of Spectral Acceleration Responses (Soil-Surface/Rock-Outcrop) of Ghoukasian Motions

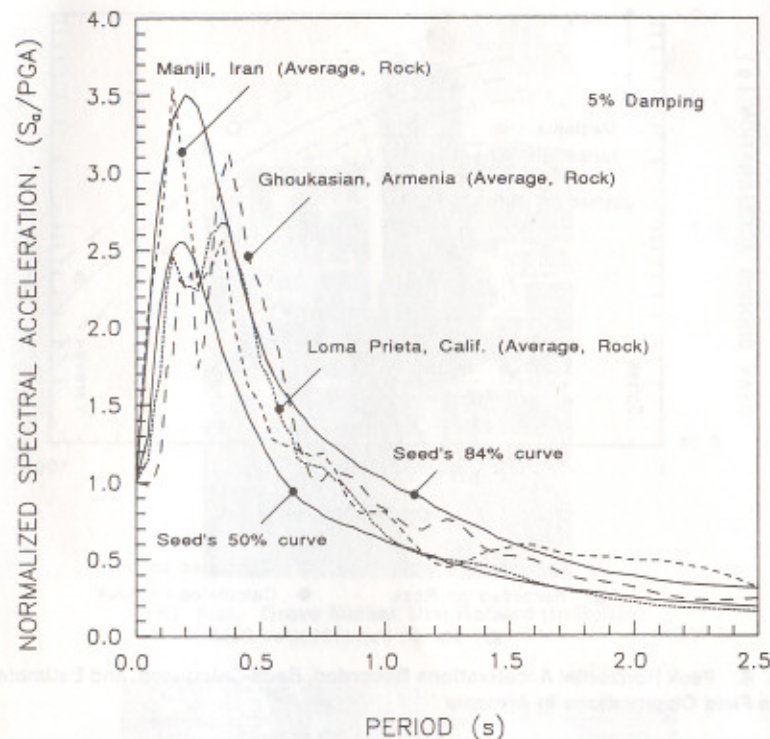
FIG. 7. Spectral Acceleration Shapes of Back-Calculated Ghoukasian Rock Motion, Compared with Other Rock-Motion Spectral Shapes (Recorded at Similar Distances)

Fig. 7 compares the normalized average spectrum computed for rock at Ghoukasian with the mean and mean-plus-standard-deviation spectral shapes obtained by Seed et al. (1976) from other rock motions recorded mainly in the Western U.S. Also shown are the recent recordings on rock at similar distances in the 1989 Loma Prieta (Housner et al. 1990), and the 1990 Manjil,

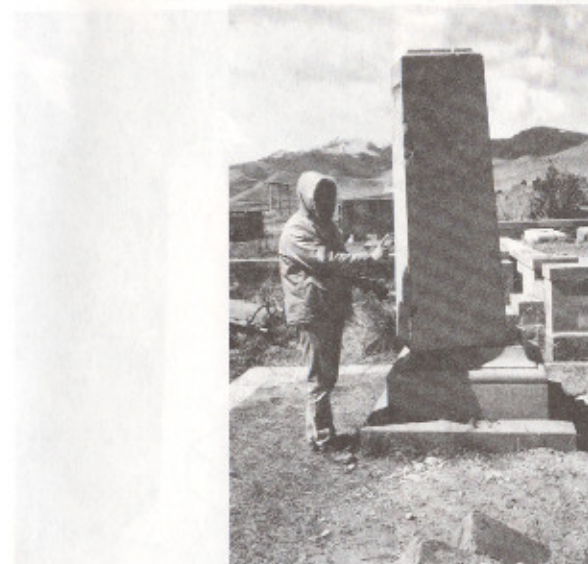
FIG. 9(a). Grave Marker That Rotated (in Spitak)

markers. On the hill in Spitak's cemetery, almost all of the grave markers had either toppled or permanently translated relative to their bases. Fig. 9 shows typical observations. Of particular interest, and at first surprising, was that all the examined markers that had translated but not toppled, had also rotated counterclockwise about their vertical axes from initial positions of facing east to final positions of facing  $20^\circ$  to  $30^\circ$  northeast, as sketched in Fig. 10. This is attributed to the twisting moment from the horizontal inertial force that acted on the blocks (eccentrically with respect to the support) while they were tilting (without toppling). Small-scale shaking-table tests conducted on model blocks confirmed this tendency of blocks to rotate whenever the direction of the horizontal base motion is not perpendicular to the weak axis of the blocks, as illustrated in Fig. 10(b). Under this condition, the component of the inertial force in the direction of the weak and strong axes of the block will tilt the block about its corner pivot point. The twisting moment of the inertial force will then rotate the block about the pivot point. This will continue until the weak axis becomes perpendicular to the direction of base motion. Then, due to symmetry, the block will simply rock.

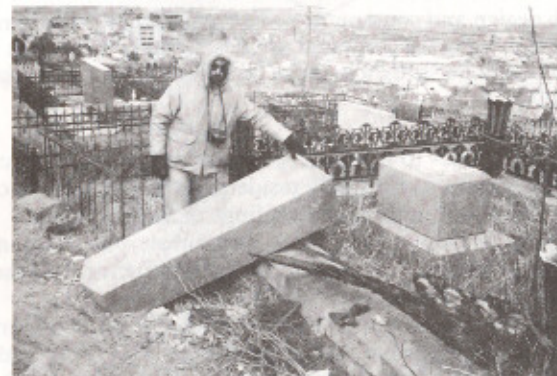
FIG. 9(b). Grave Marker That Topped (in Spitak)

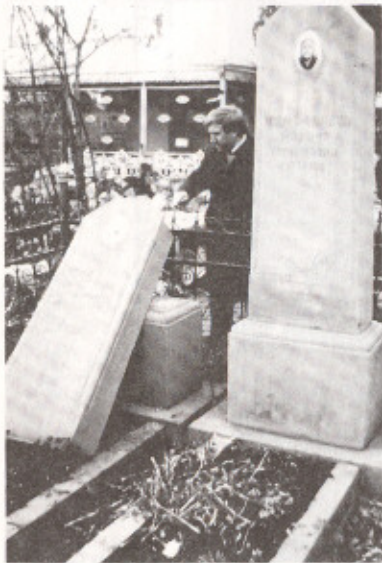
FIG. 9(c). Grave Marker That Topped (in Leninakan)

In Leninakan, the city and its cemeteries are underlain by an old lake bed. A few grave markers had toppled; but most showed no movements relative to their granite bases [Fig. 9(c)]. In Kirovakan, approximately 10 km from the causative fault, an old cemetery northeast of the city is located on outcropping rock. Surprisingly, there was absolutely no evidence of any permanent displacements of the markers of this cemetery [Fig. 9(d)]. We carefully checked and verified that the markers were indeed in simple contact with their bases. This suggests that rock motions in Kirovakan were significantly smaller than in Spitak.

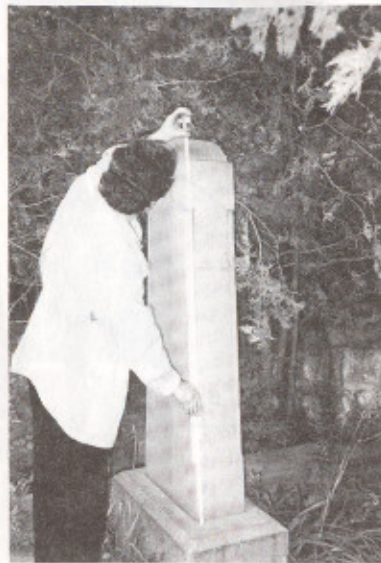
FIG. 9(d). Grave Marker That Did Not Topple (in Kirovakan)

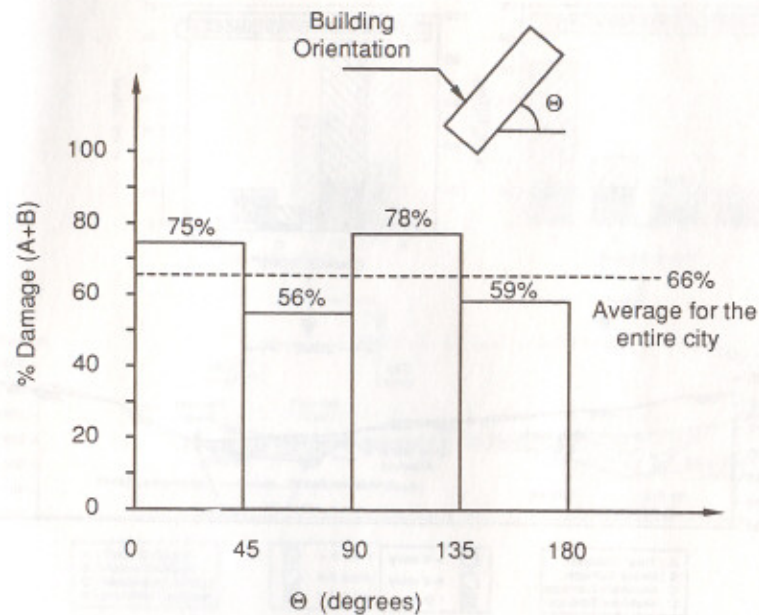
FIG. 17. Results of Directionality Analysis in Leninakan

To unveil any evidence of a predominant direction of ground motion in Leninakan, damage statistics were compiled in terms of building orientation. Buildings with their weak axes perpendicular to a potential predominant direction of motion would have an increased likelihood of damage. Thus, damage statistics were analyzed as a function of  $\theta$ , the angle between the weak axis of a building, and the E-W direction. For this investigation, only category 2 buildings were considered because most of these buildings were rectangular in plan section, allowing  $\theta$  to be easily and reliably determined. Also, the data for this category was abundant. The resulting statistics are summarized in Fig. 17. Evidently, the extent of A and B damage is insensitive to  $\theta$ , within, of course, the expected experimental scatter. Hence, the writers conclude that in Leninakan there were no apparent directionality effects on building damage.
