LIQUEFACTION AND EMBANKMENT FAILURE CASE HISTORIES, 1988 ARMENIA EARTHQUAKE

By M. K. Yegian,¹ V. G. Ghahraman,² Members, ASCE,
and R. N. Harutiunyan³

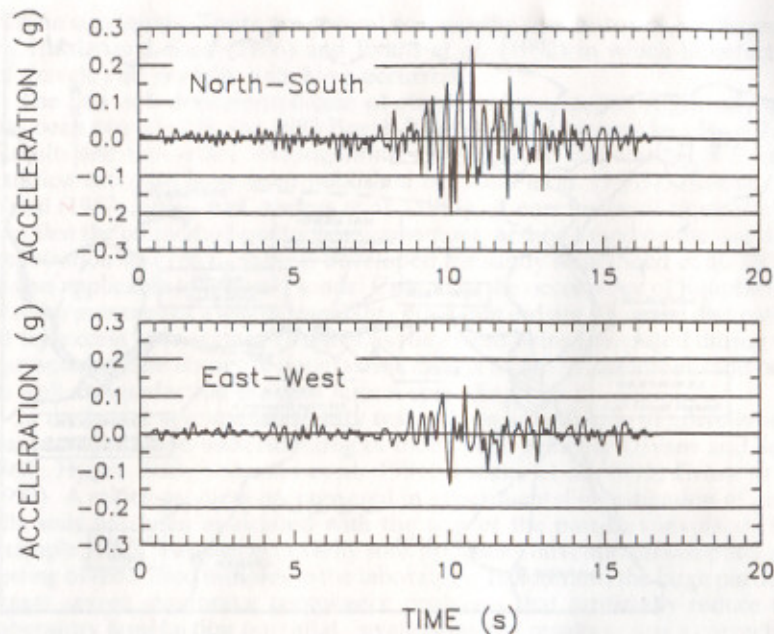
FIG. 2. Two Components of the Computed Rock Motion in Town of Ghoukasian, 25 km from the Northwestern Tip of Fault

To assess if the failure was due to large inertial forces and without liquefaction, analysis of permanent earthquake-induced deformations using Newmark's (1965) sliding block analogy with $k_y = 0.25$ g was performed. The time history of the rock outcrop motion inferred at Ghoukasian (Fig. 2) was used as excitation after scaling to an upper bound PGA of 1.0 g. The results show that the expected permanent deformations are less than about 0.5 m if the fill had not liquefied. Since the actual deformations were as large as 2 m laterally and 3 m vertically, it is concluded that the failure was most likely associated with liquefaction-induced flow slide. Additional factors that support this conclusion include:

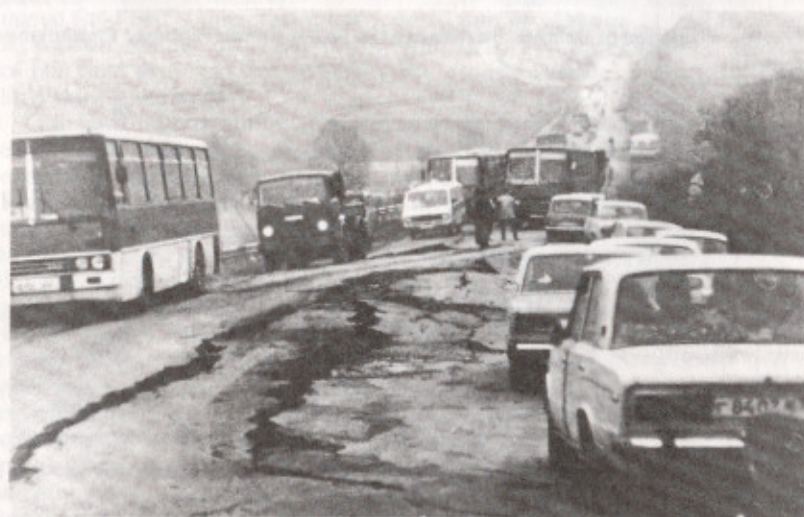
At site 1, one km from the fault (Fig. 3), a highway embankment failed. Fig. 4 shows a photograph of the embankment taken after its failure. This embankment supported a highway that was the primary link between the three major Armenian cities of Leninakan (now called Kumayri), Spitak, and Kirovakan, located in the earthquake disaster region (Fig. 1). Its failure seriously impeded the relief efforts immediately after the earthquake.

FIG. 4. Photograph of Failed Spitak Highway (Site 1)

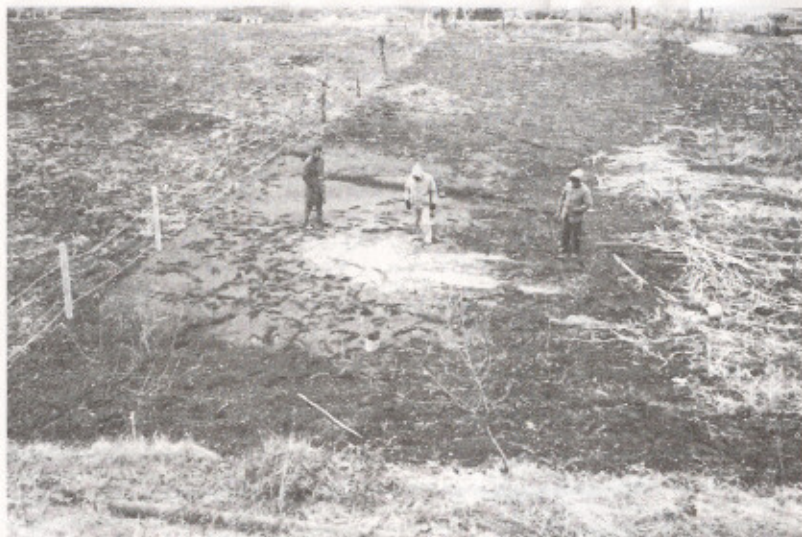
During our reconnaissance trips and surveys in the vicinity of the fault, northwest of Spitak, we observed sand boils, with silty sands spread on the ground surface and gravels lodged in the blow-out holes (Fig. 6). These sand boils were located as close as 15 m from the toe of the failed section of the highway embankment.

FIG. 6. Evidence of Sand Boils Adjacent to Failed Spitak Highway Embankment (Site 1)

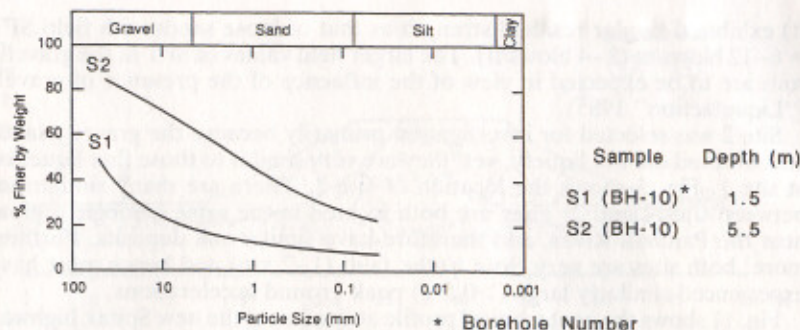
FIG. 12. Grain-Size Distribution Curves of Soil Samples from Site 2

and presence of embankment), whereas at site 2 the top layer covering the gravelly sand is very permeable, allowing the rapid dissipation of excess pore pressures. The higher fines content at site 2 (22% compared to <5% at site 1) may have also contributed to a lesser degree to its greater resistance to liquefaction. However, the third case history (site 3), presented in this paper, has shown that this was not a significant factor; liquefaction of a similar gravelly sand with 25% silt content did take place.

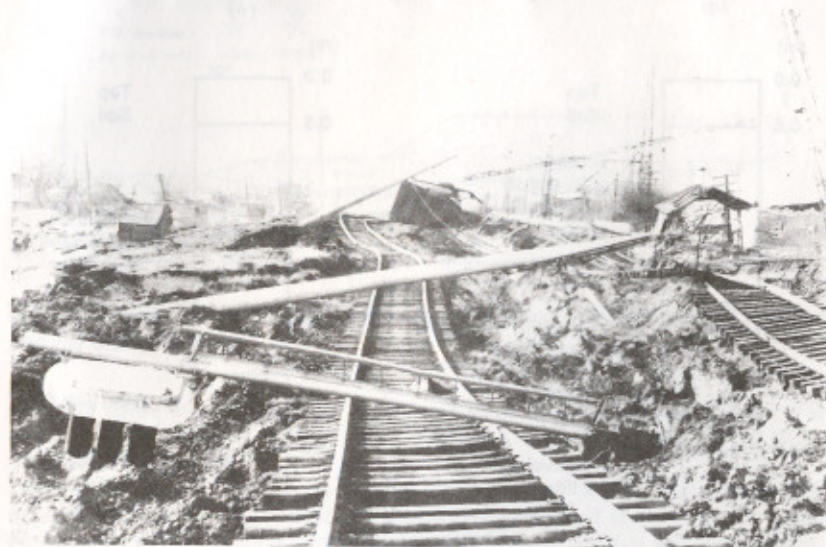
This site is at the railway station in the town of Nalband, Armenia, where a 240 m long section of this railway embankment failed as portrayed in Fig. 13 (A. Karakhanian, personal communication, 1989). The railway was the only link between Armenia and its northern neighboring states, and its failure paralyzed the earthquake relief efforts, just as the Spitak highway failure (site 1) did. Similar to sites 1 and 2, the railway embankment is also located in the Pambak River Valley (Figs. 3 and 5). Based on photographs, eyewitness accounts, and our field surveys, cross sections of the embankment before and immediately after the earthquake were constructed and are sketched in Fig. 14. Due to the shape of the natural terrain of the area, in the section of the embankment where the failure occurred the water table is usually high as shown in this figure. In contrast, there was no evidence of high water table adjacent to the failed section along the embankment. Field observations of the failed embankment suggest a flow slide type of failure in which the berm and the embankment foundation material experienced significant lateral movements that led to cracking and up to 3 m of settlement of the embankment. Liquefaction was considered to be one likely cause for this failure; yet the possibility of such deformations induced solely by large inertial forces (associated with up to 1.0 g acceleration) without liquefaction was also considered. Both of these potential causes were investigated and are discussed next.

FIG. 13. Photograph of Failed Embankment at Railway Station in Nalband (Site 3) (Photo Courtesy of A. Karakhanian, 1989)
