Liquefaction during the 1990 Manjil, Iran, Earthquake, I: Case History Data

by M. K. Yegian, V. G. Ghahraman, M. A. A. Nogole-Sadat, and H. Daraie

Abstract During the 1990 Manjil, Iran, earthquake ($M_S = 7.7$), an estimated 35,000 people lost their lives and more than 300,000 were left homeless. The earthquake ground shaking caused enormous destruction of unreinforced structures. In addition, widespread liquefaction contributed significantly to building damage in towns as far away as 85 km from the ruptured fault. Following the earthquake, the authors surveyed the liquefaction regions, conducted geotechnical field explorations, and documented case histories on liquefaction of level ground, liquefaction-induced building settlement, permanent ground displacement, and performance of piles and piers in liquefied soils. This article presents and discusses the data of the case histories investigated. In addition, based on the evidence from the Manjil earthquake, the importance of geologic input in mapping of liquefaction potential in earthquake-prone regions is demonstrated. In the companion article, the authors present the results of their analyses of liquefaction-related case histor

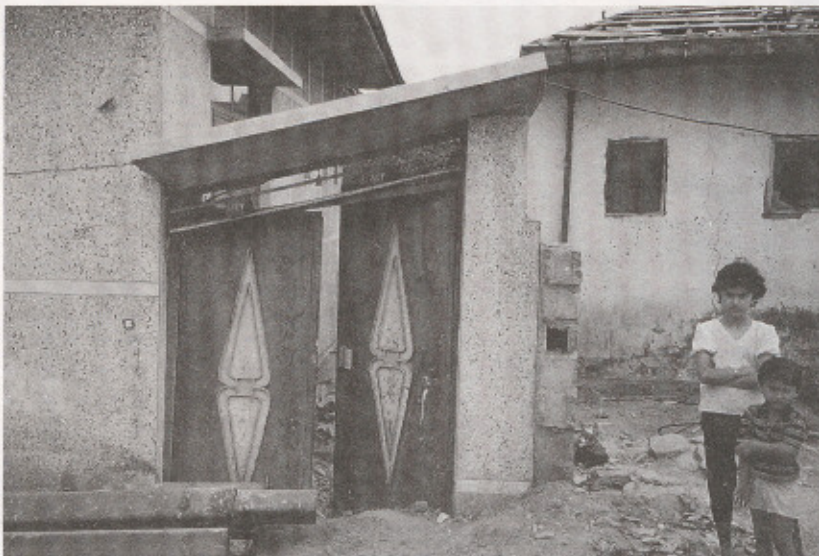
Figure 7. Photograph illustrating liquefaction-induced building settlement in Astaneh-Ashrafieh. (Note the distorted door-jamb depicting the magnitude of the building settlement.)

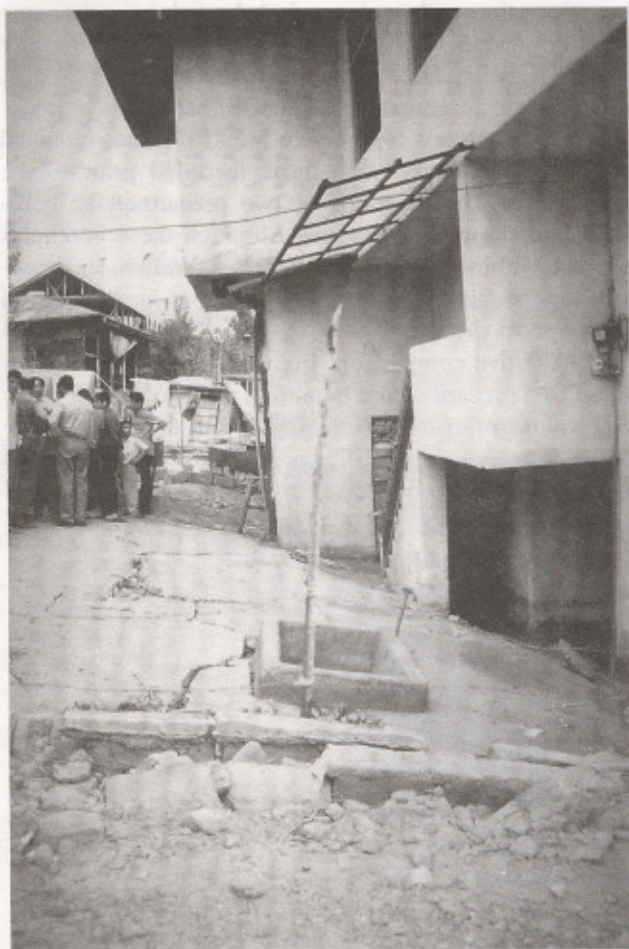
Figure 8. Liquefaction-induced settlement (70 cm) of a two-story building in Astaneh-Ashrafieh.

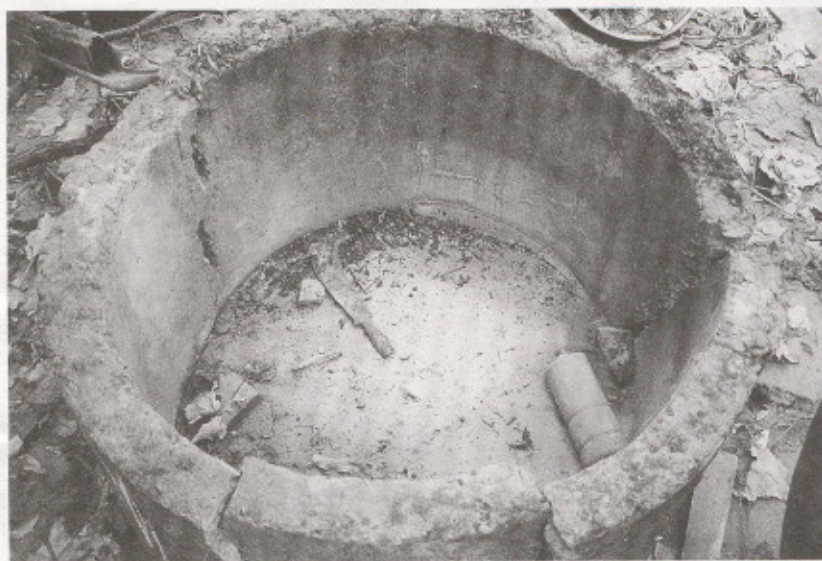
Figure 9. A water well in Astaneh-Ashrafieh filled with rising liquefied sand.

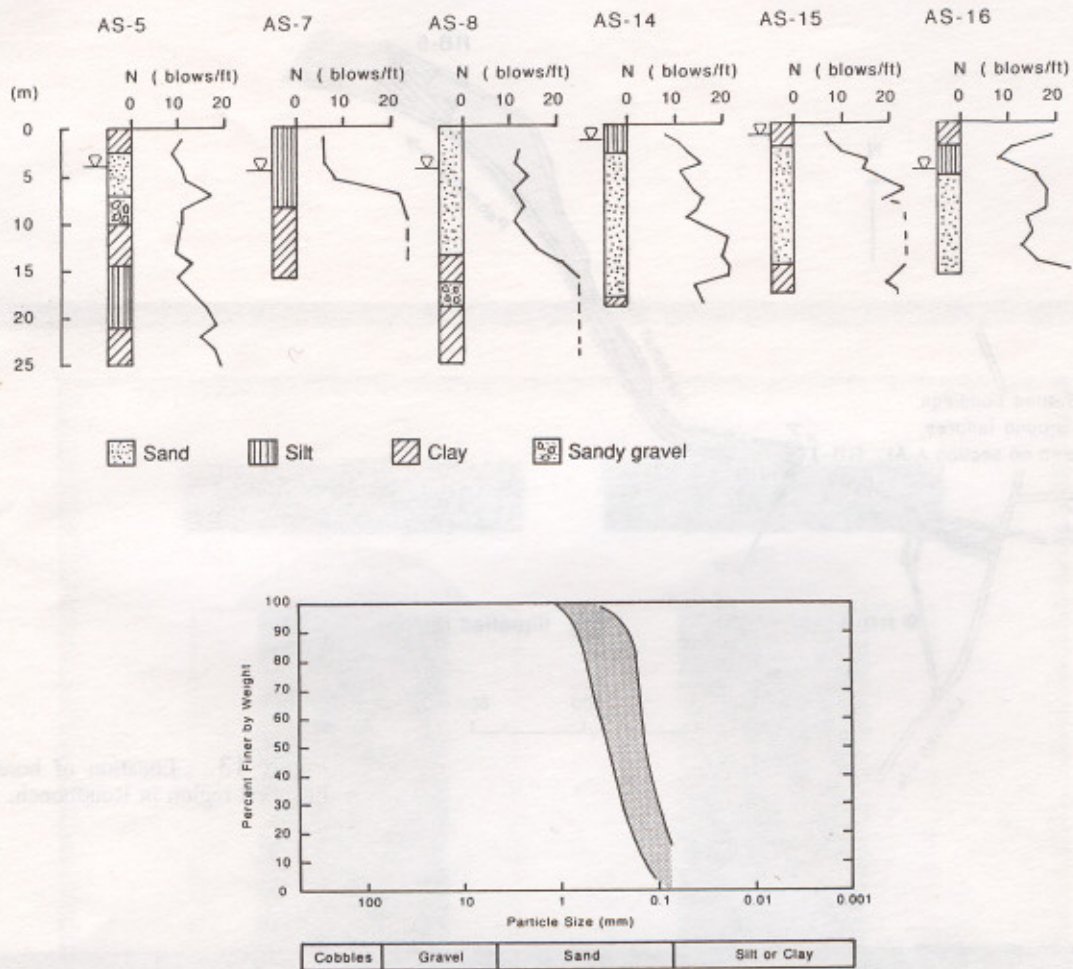
Figure 11. Borehole logs from nonliquefied sands in Astaneh-Ashrafieh, and range of grain-size distribution.

ing, since the sands in Astaneh-Ashrafieh have the same geologic origin. A visual comparison between the SPT results of the liquefied and nonliquefied sands shows that, as expected, in general the liquefied sands are looser.

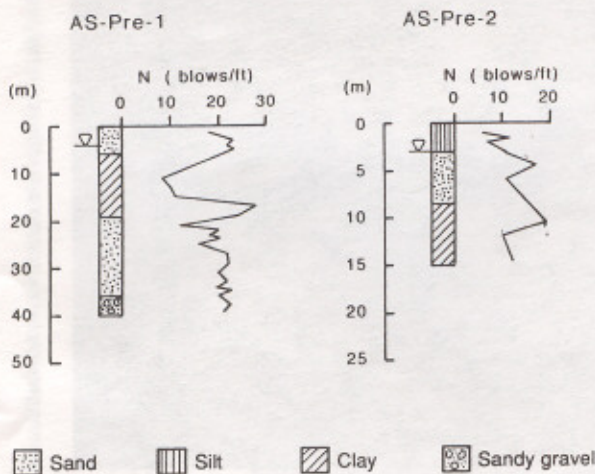
Figure 12. Preearthquake borehole logs from Astaneh-Ashrafieh.

It is of interest to compare the SPT values obtained after the earthquake with those recorded prior to the earthquake. The locations of two preearthquake boreholes are shown in Figure 6. Although these boreholes are not within the city of Astaneh-Ashrafieh, and considering the fact that subsurface conditions may vary even within short distances, they are close enough to be used for qualitative comparison. Figure 12 shows the logs of these two preearthquake boreholes. It is evident that the SPT values prior to the earthquake for the sands in Astaneh-Ashrafieh, especially for the depth between 5 and

10 m, are similar to those obtained after the earthquake (between 10 and 20 blows/ft).

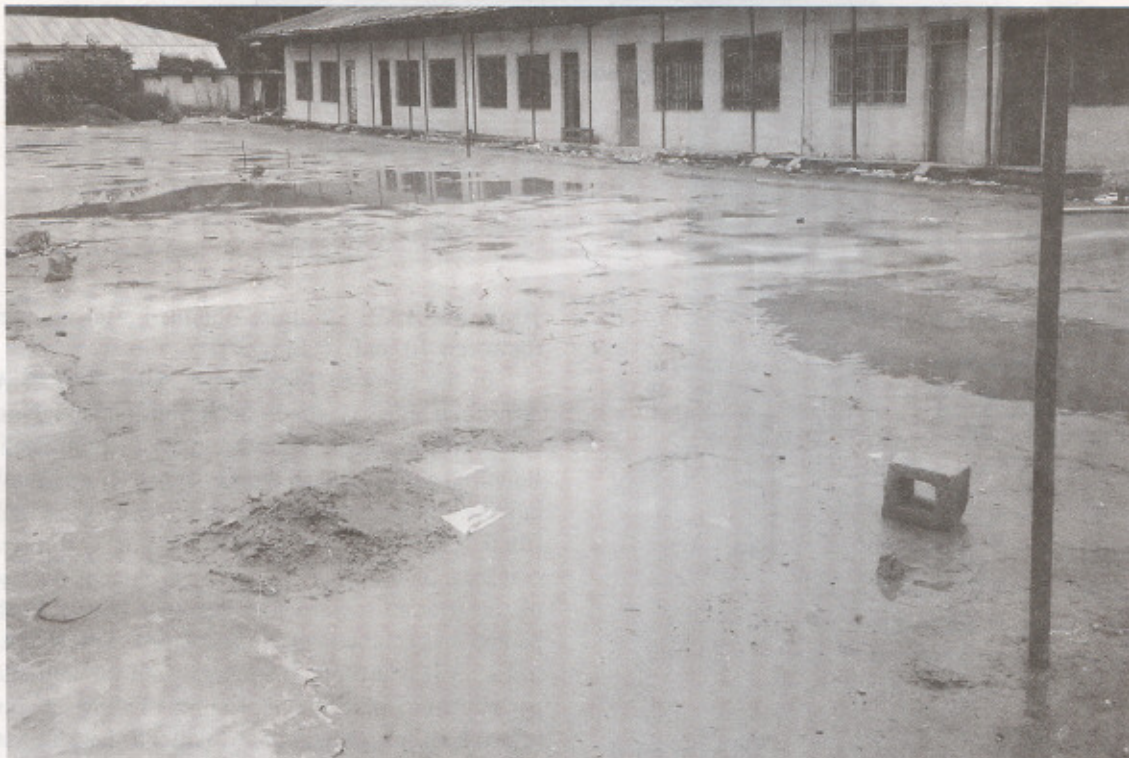
Figure 14. Photograph of a school yard in Roudboneh covered with ejected liquefied sand and water.

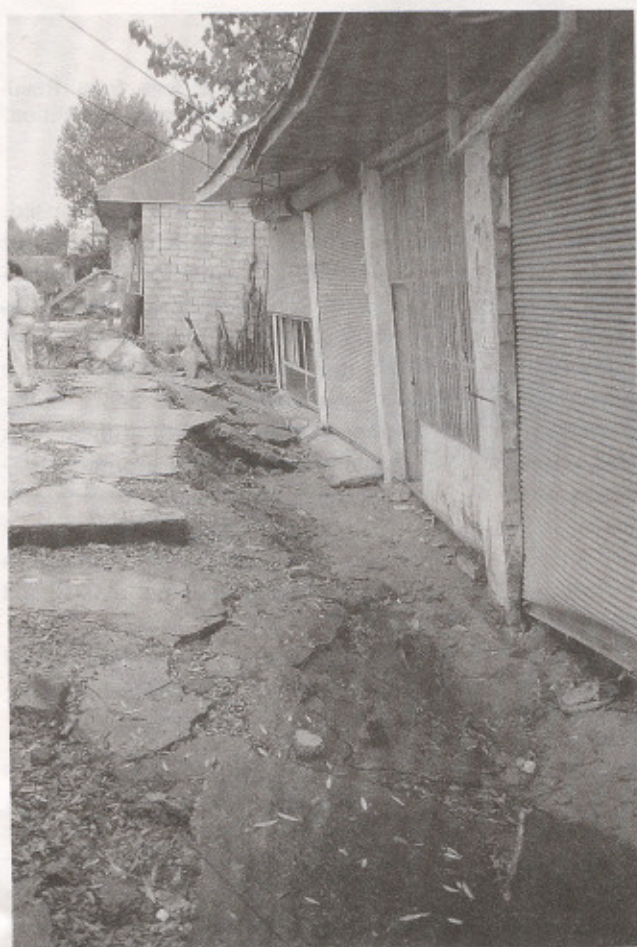
Figure 15. Photograph depicting liquefaction-induced settlement (60 to 70 cm) of a row of stores in Roudboneh.

In the town of Roudboneh, 5 km east of Astaneh-Ashrafieh (Fig. 5), the liquefaction-induced damage was extensive. Figure 13 shows a map of Roudboneh and the liquefied region along the Heshmat River. Evidence of liquefaction was abundant in the form of sand boils, sand-filled water wells, building settlements, settlement and cracking of the roadway, and permanent displacements of the ground toward the Heshmat River. In the companion article, the geotechnical profile along A-A (shown in Fig. 13) is presented and analyzed for settlements and permanent displacements. Figure 14 shows a photograph of a school playground that was flooded with ejected sand and water. A row of stores that experienced settlement of about 60 to 70 cm is shown in Figure 15. In Roudboneh, five boreholes were made and their locations are

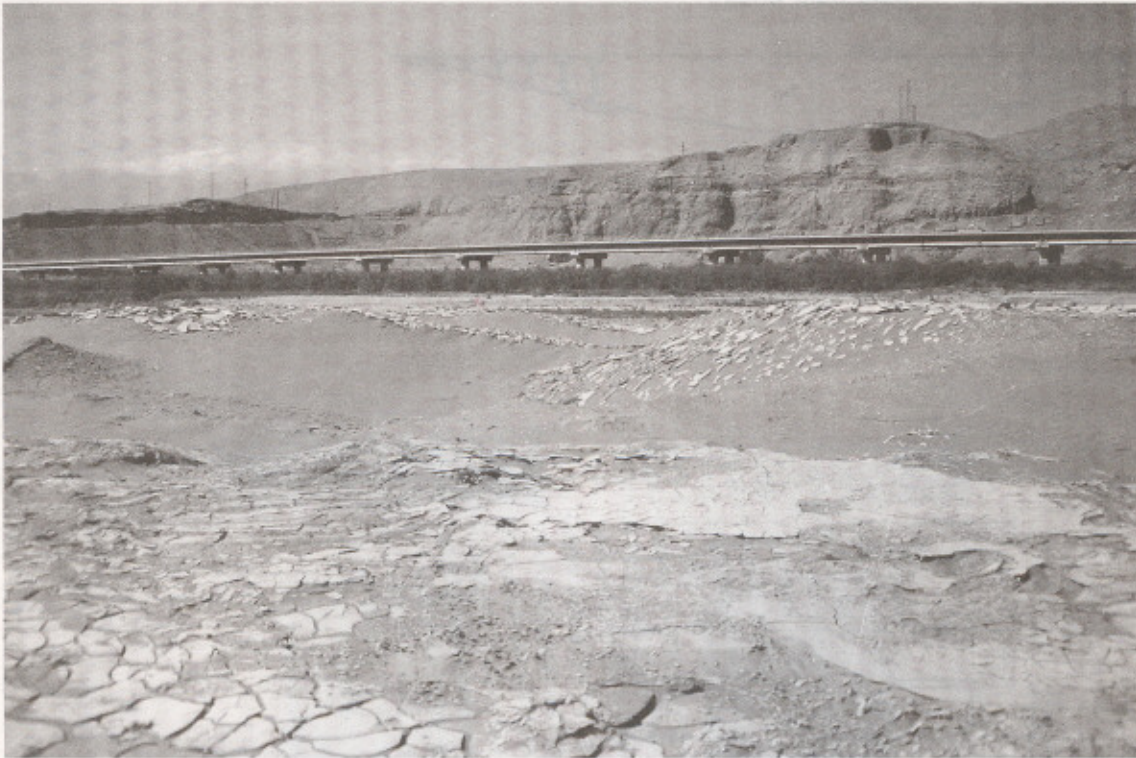
Figure 23. Photograph depicting liquefied sands that have laterally moved toward the Shahroud River.

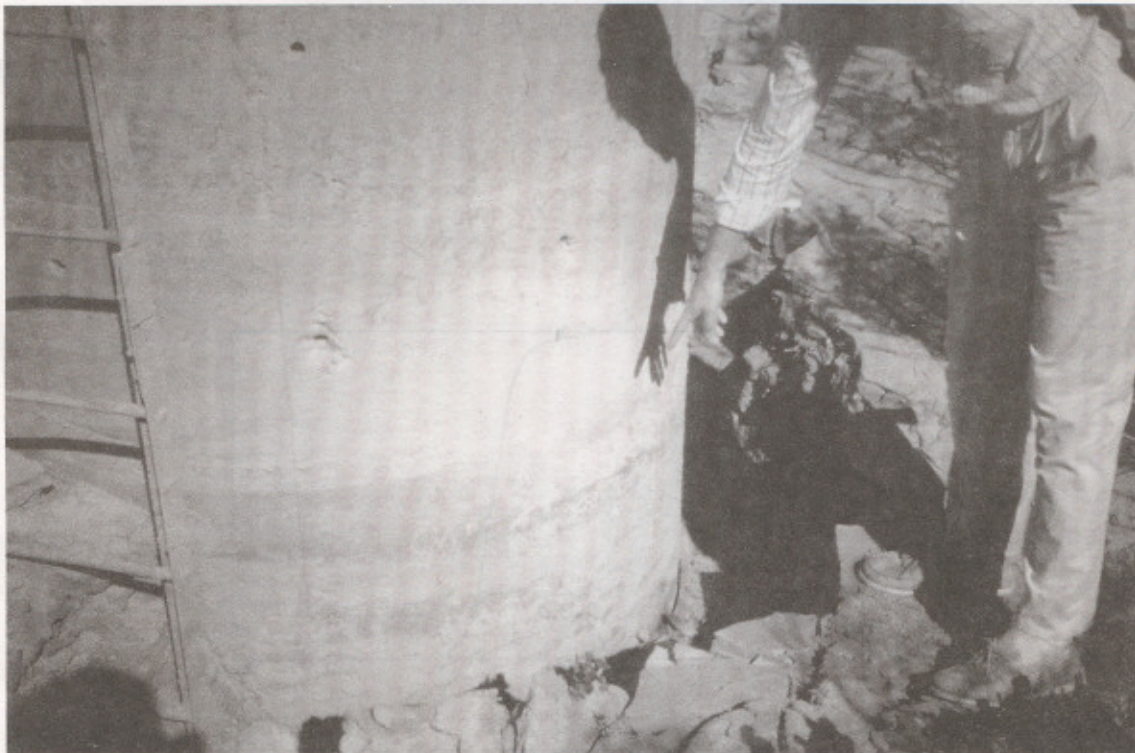
Figure 24. Photograph showing settlement and permanent lateral displacement of the ground around the Bala-Bala bridge pier.

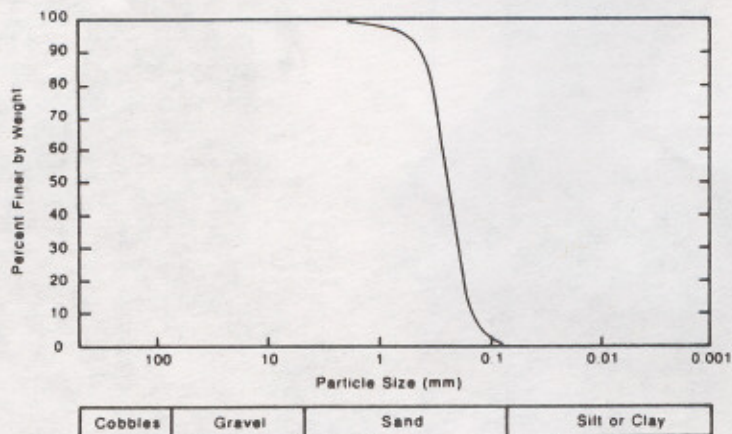
Figure 26. Grain-size distribution of the liquefied sands from the Bala-Bala region.

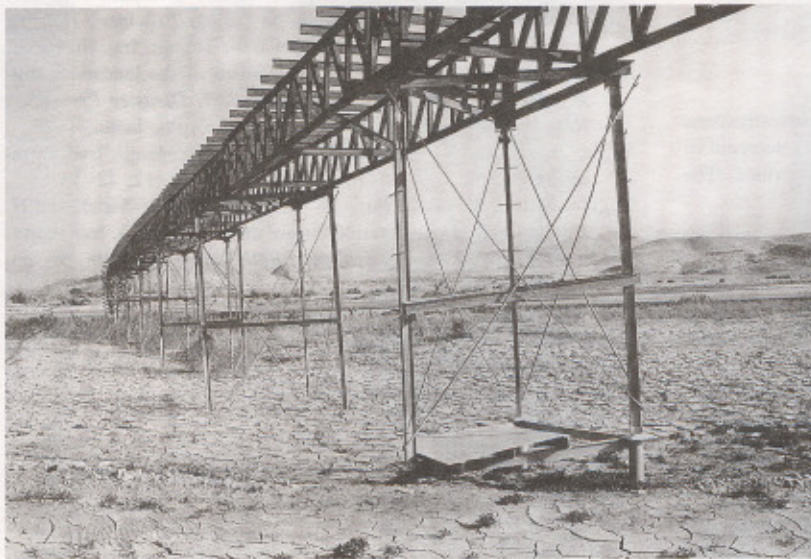
Figure 28. Photograph of a trestle founded on liquefied sand.

a steel trestle founded on liquefied soil was investigated. Figure 20 shows the location of the trestle relative to the bridge. In Figure 27 a profile along section B-B is presented that describes the site conditions and observations made. Figure 28 shows a photo of the trestle with supports founded on 15-cm diameter steel pipe piles. Since most of the piles were embedded in the dense sandy gravelly river bed, no appreciable settlement of these piles was observed. Yet, liquefaction-induced ground settlements of up to 20 cm were observed and measured adjacent to the piles, as shown in Figure 29. The density of the sands at the trestle location was approximated in a similar manner as that for the bridge site, using hand cone penetrometer data.

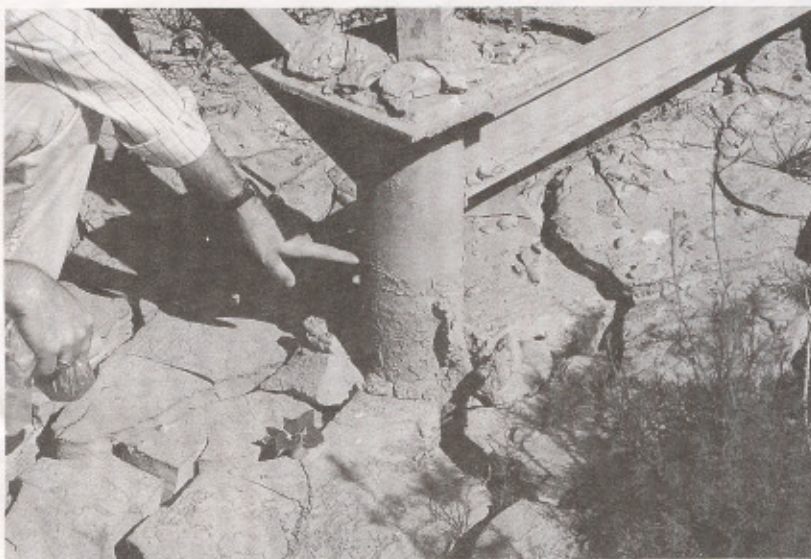
Figure 29. Photograph depicting ground settlement around the 15-cm-diameter pipe piles of the trestle.
