The Northridge Earthquake of 1994: Ground Motions and Geotechnical Aspects

Paper No. 14.01

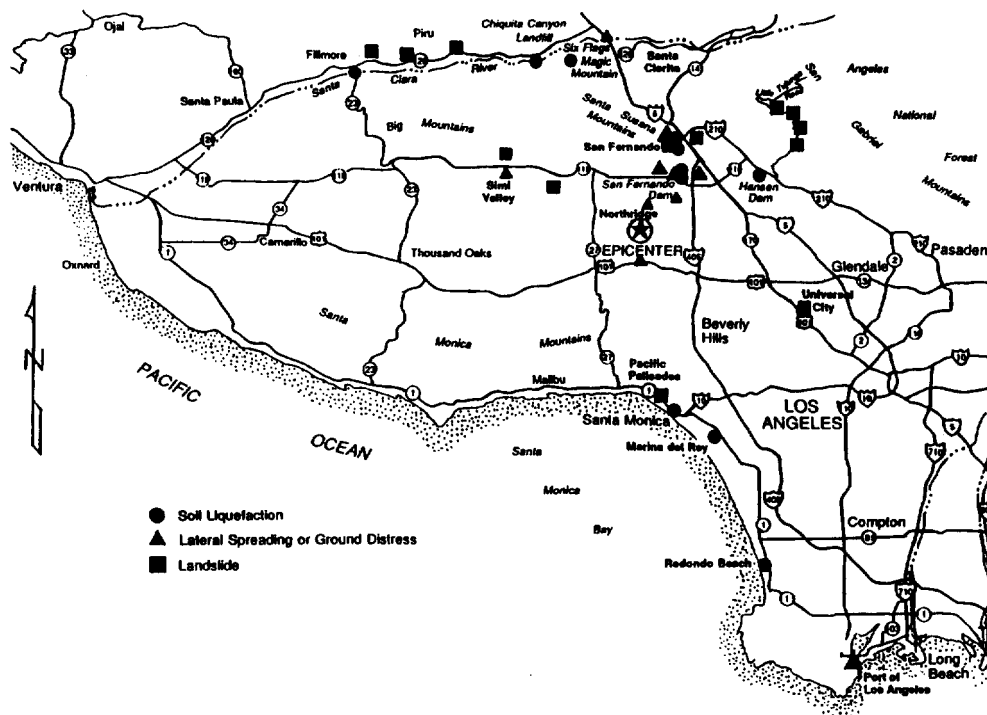
Manifestations of geotechnical failures and damage could be observed at many different locations as far away as 50 km from the general epicentral region. Fig. 4 shows the approximate locations of sites where liquefaction and landslides were observed. Evidence of liquefaction has been observed in the Simi Valley, 15 km northwest of the epicenter. Also, soil liquefaction near the toe region of a section of Highway 126 near the town of Piru may have contributed to its failure. In the parking lot of the Santa Monica Pier, liquefaction of the underlying sands had caused extensive cracking of the pavement and ejection of sand, as shown in Fig. 5.

Fig. 4 Map of the earthquake affected region with locations of geotechnical observations. (from EERC Report, 1994)
